# Post Installation Performance of Cavity Wall & External Wall Insulation

This scoping study presents the results of an investigation of unintended consequences (unplanned side-effects such as damp and cracking in walls or other faults) for a small sample of Welsh dwellings which have been retrofitted with wall insulation. The primary aims of this study are:

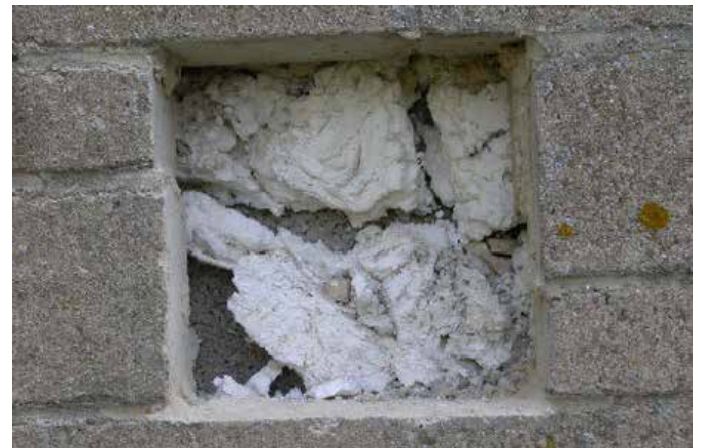
In this particular example the effect of rain water driving into the masonry of a building can be seen in Figures 3 and 4. The results are that the moisture penetrates the outer leaf brickwork leading to the wetting of the insulation materials, increased damp penetration and a reduced thermal performance of the material.

Figure 3: Example of saturated insulation

Figure 4: Example of saturated insulation

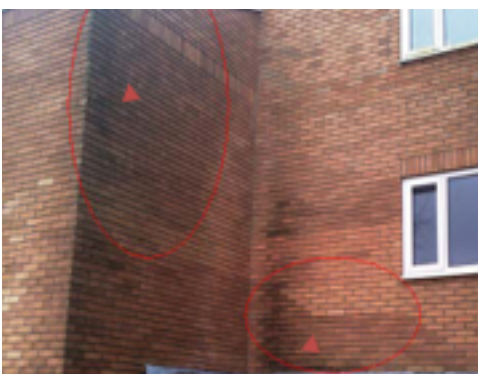
Many of the properties had experienced damage and deterioration as a result of the exposure to the weather. Mortar and bricks used in the construction are already saturated, with discolouration and mould growth evident. Examples are shown in Figures 5 & 6 below.

Figure 5: mould on saturated brickwork

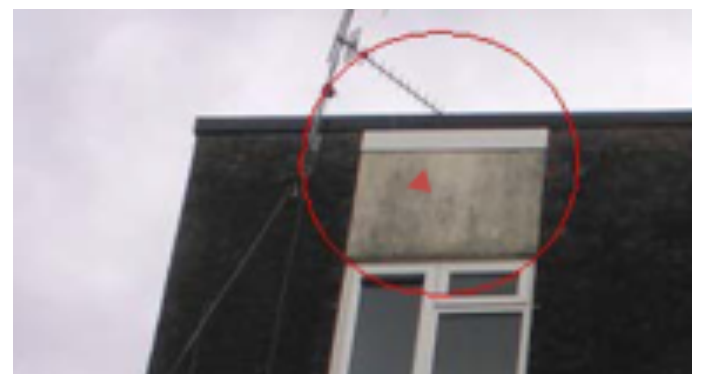
Figure 6: mould on saturated render panels

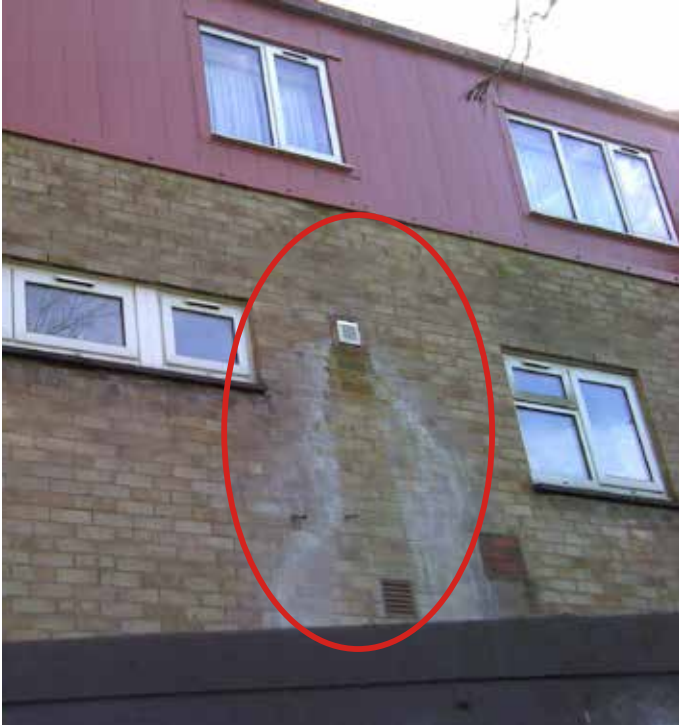
**Figure 7:** Water dripping from extract fan cover and staining the walls

been repaired badly. This causes staining and increased risk of moisture penetration to the building, as shown in Figures 7 & 8.

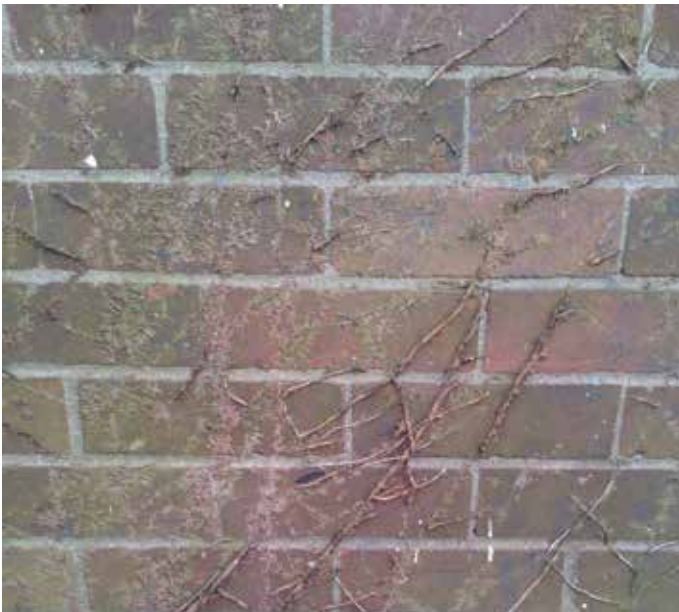
**Figure 9:** Plant growth attached to walls

environment. If the plant growth is not addressed then this could help the wall become saturated, with an increased risk of the insulation in the cavity becoming damp. Examples of this damage are shown in Figures 9 & 10 below.

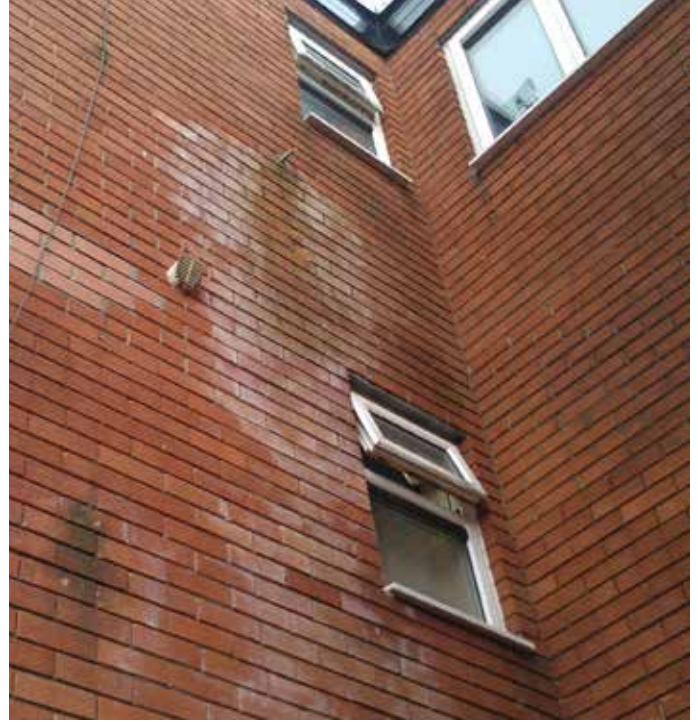
**Figure 8:** Leaking overflow pipe staining the brickwork

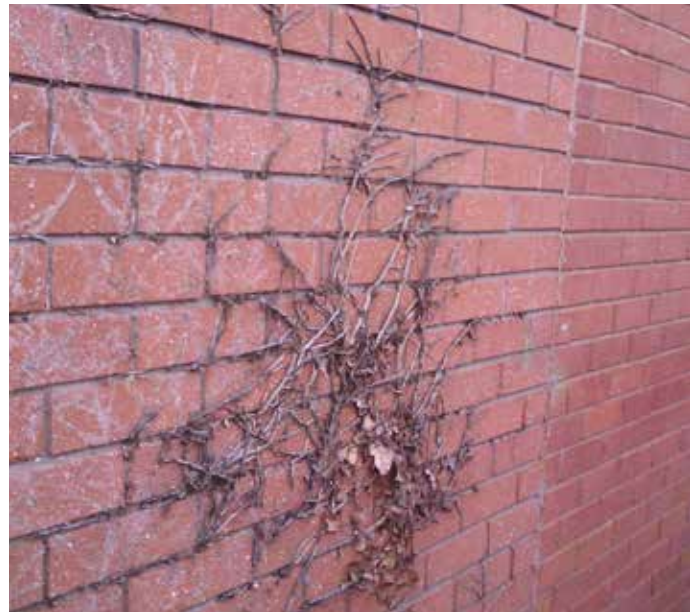
**Figure 10:** Plant growth and mould, indicating wet substrate

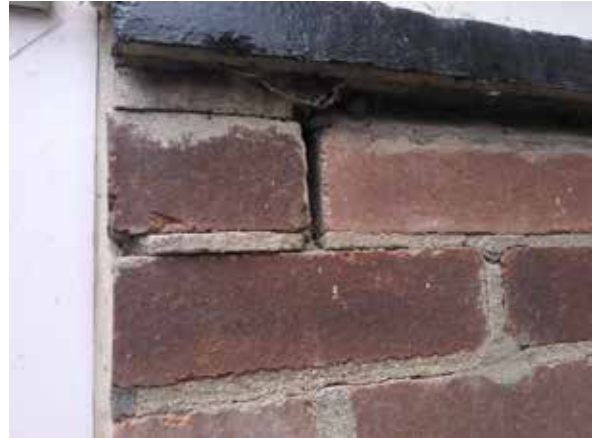
damage in the main would have been created by exposure to wind driven rain. Deteriorated mortar joints are entry points for moisture which can lead to any insulation in the cavity becoming wet.

Figure 12: Cracked and missing

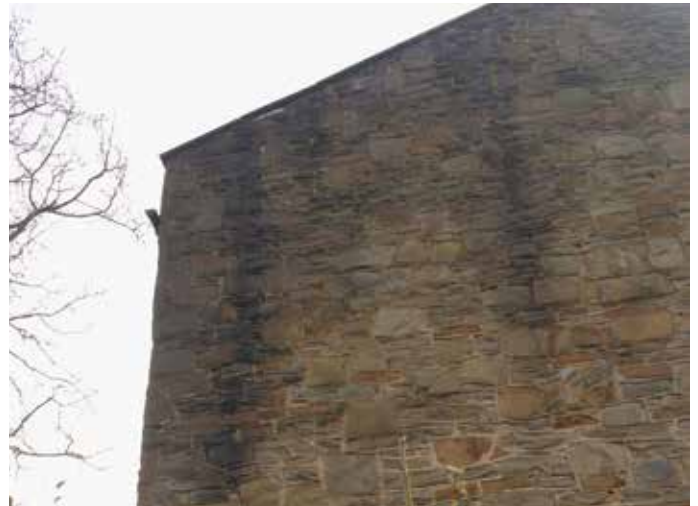
Other issues were identified where rainwater has overblown the roof and has saturated elements of the wall as shown in Figures 13 & 14 below.

Figure 14: Staining from roof water run off

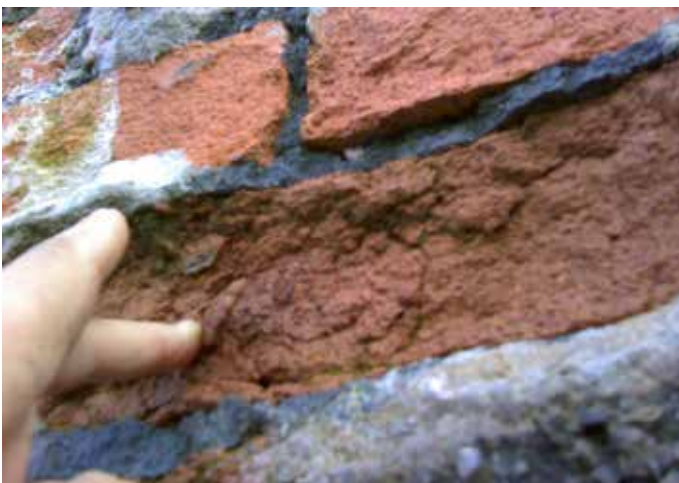
The results of the site surveys undertaken indicated by figures 15 and 16 show walls that have at some stage been saturated, and then excessive cold weather has resulted in "Freeze – Thaw – Frost" damage. With the faces of numerous bricks

being blown - severe frost damage and cracked rendering may permit higher than normal moisture content in the outer leaf. Insulation of the wall can be expected to increase the rate of deterioration.

Figure 15: Significant brick face loss

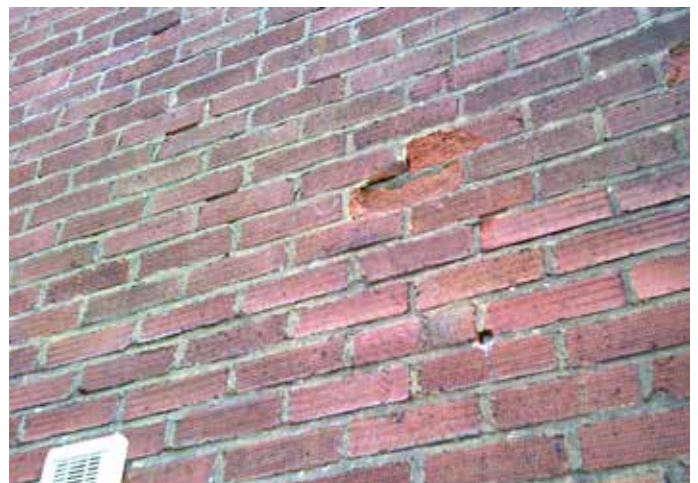
Figure 16: Missing brick faces

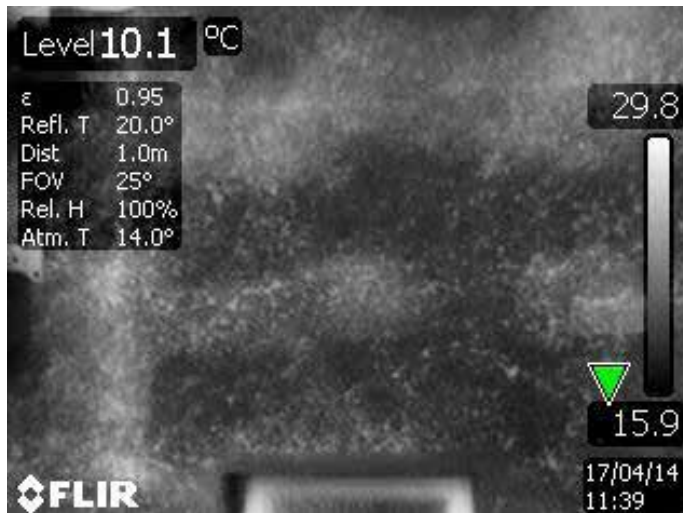
of continuity (voids) in the insulation, probably caused by either slump or incorrect installation procedures being used, with the darker areas indicating lack of thermal performance and cold bridging.

Dark patches indicating missing or slumped insulation materials.

Figure 21: Inconsistent insulation, shown on IR images

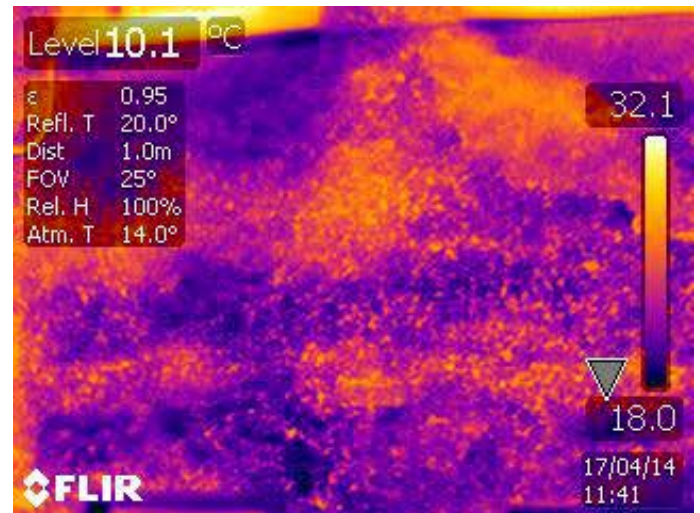
Figure 22: Inconsistent insulation in the same location

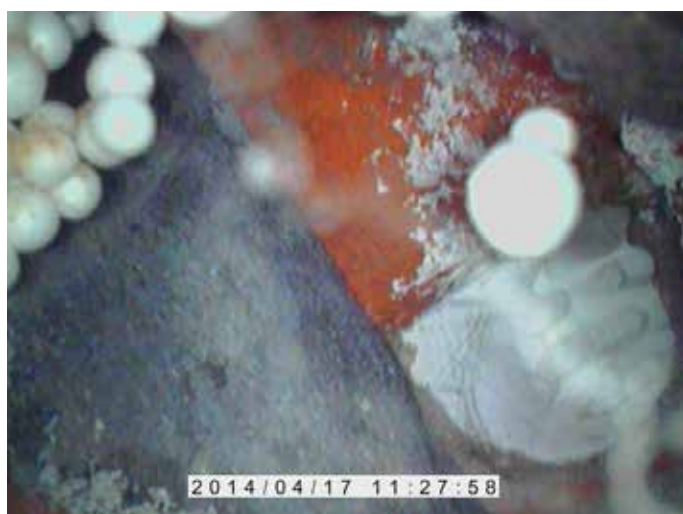
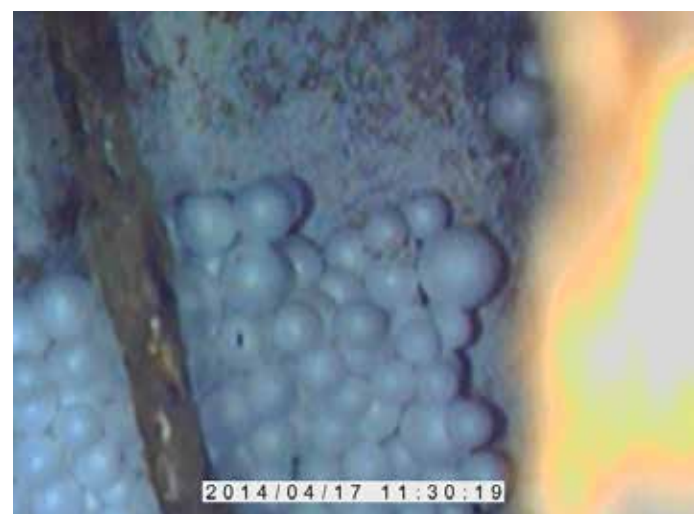
Close investigation of the voids being indicated by the IR imaging using a borescope camera confirms that in many places the insulation is in fact missing or slumped, examples of this can be seen in Figures 23, and 24 below.

Figures 23 & 24: Missing insulation below rear kitchen window and rear bedroom window

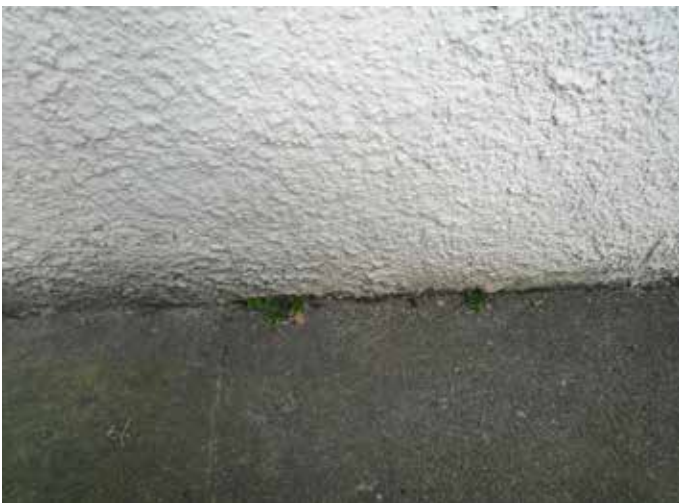
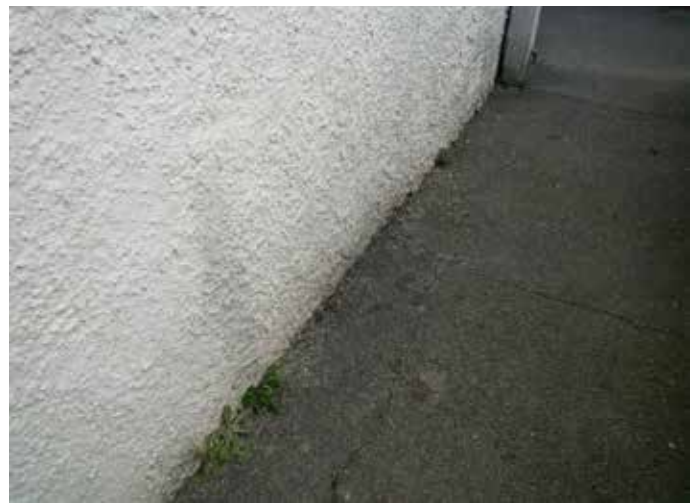
Figures 25 & 26: showing render to ground formation level at the rear of the property, and no weep holes

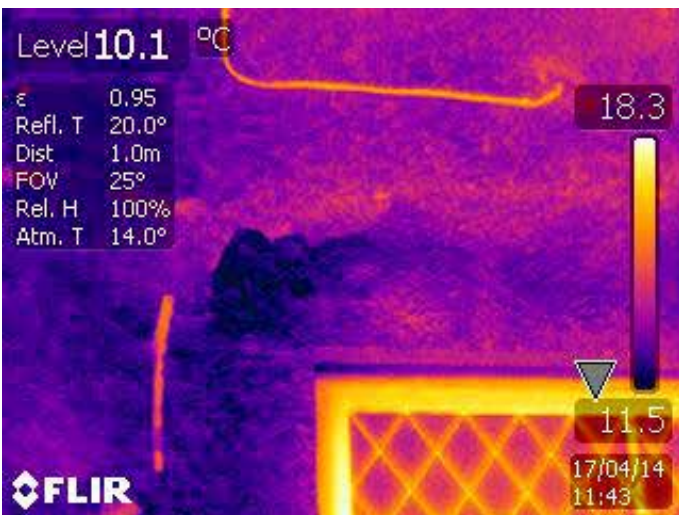
There are in addition other areas of cracked and spalled render shown in Figure 28. Cold bridging shown in Figure 27 may be leading to timber rot in the window frames to the property which will be allowing moisture ingress into the cavity area. We can conclude that the maintenance strategy for this property is insufficient and is likely to be leading to moisture entering the insulated cavity.

Figure 27: Cold Bridge introduced at area of spalled render.

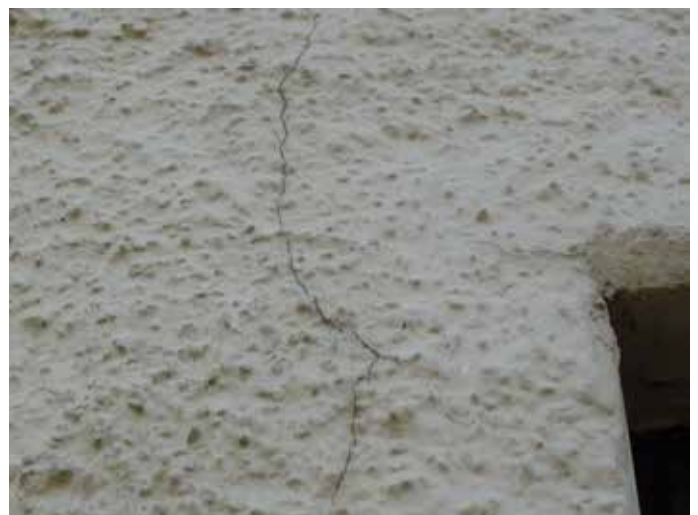
Figure 28: Cracked render at the property

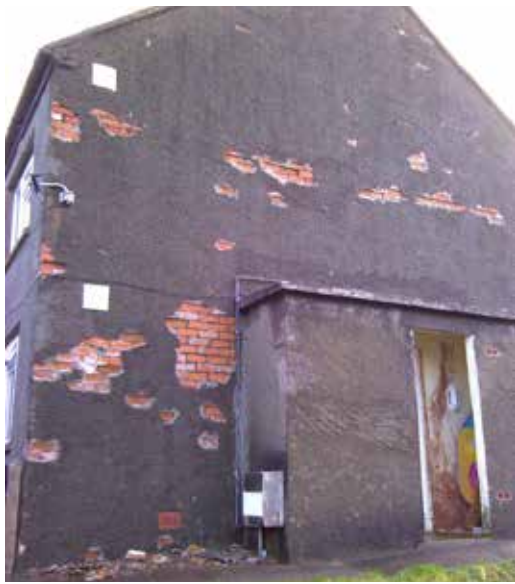
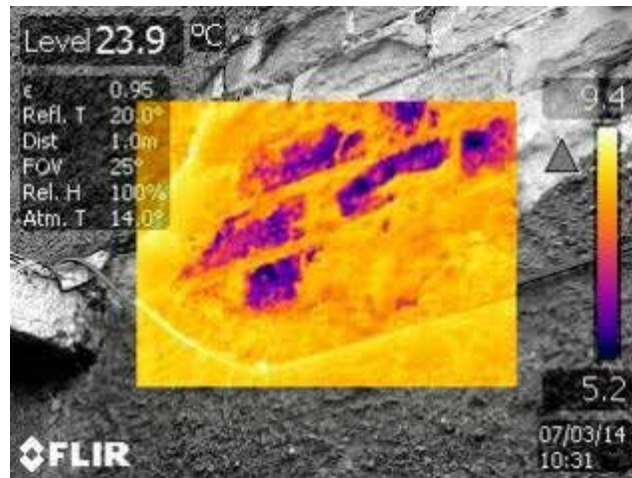
Figures 29 & 30: Gable end wall damage caused by saturation and blown render

Figures 29 & 30 show the level to which some of the render has deteriorated badly, due to the moisture content of the render and substrate.

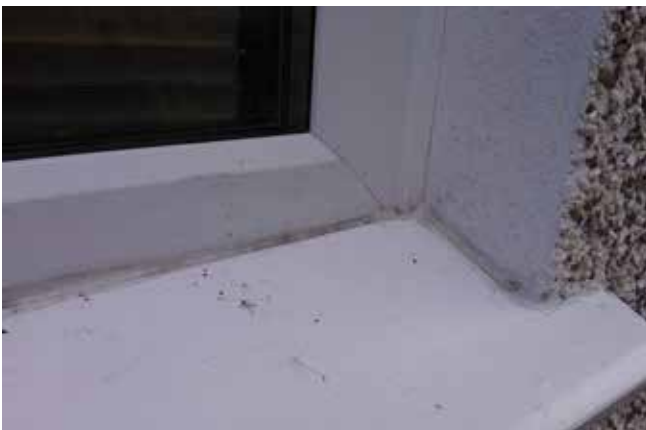
Figure 31: Uninsulated window reveal

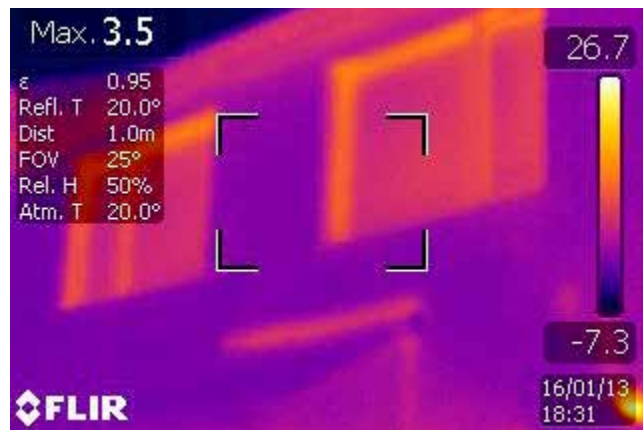
Figure 32: accelerated heat loss through an uninsulated window reveal

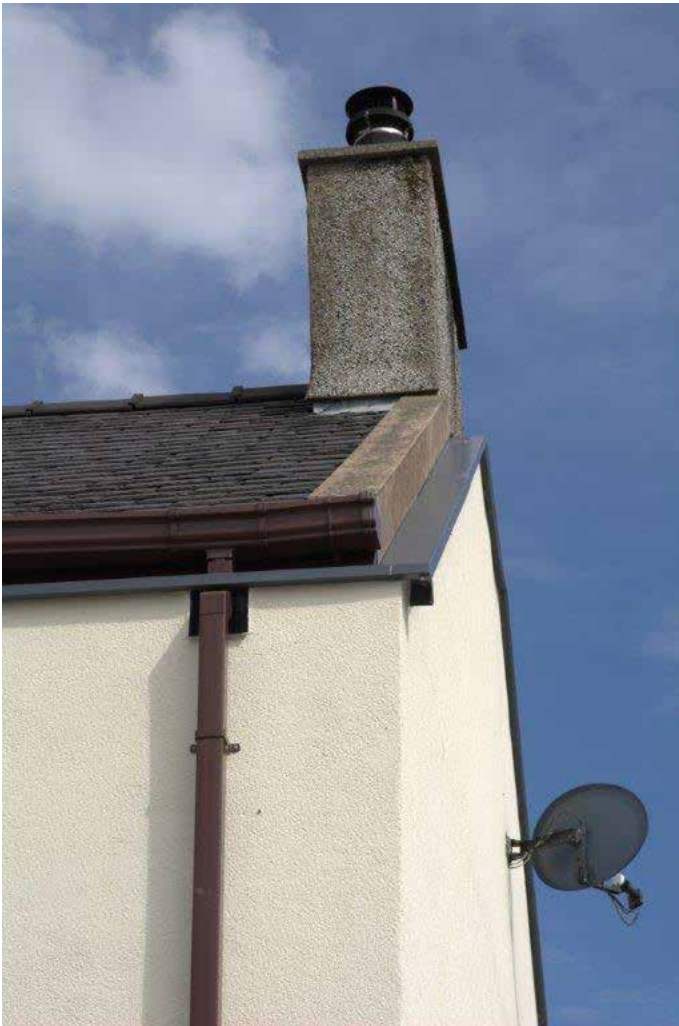
flexible sealant to ensure water tightness. Good practice would dictate that roof line be extended by a minimum of 35-40mm passed the insulation, to provide protection to the top of the EWI system from inclement weather. An example of a typical roof that has not been extended is shown in Figure 33 below.

**Figure 33:** Roof of the building not extended to protect the insulation

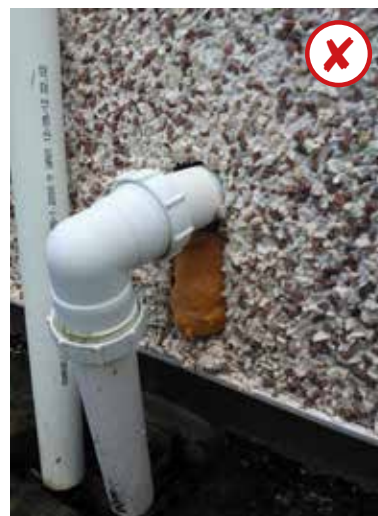
Figure 35: Unsealed pipe penetration

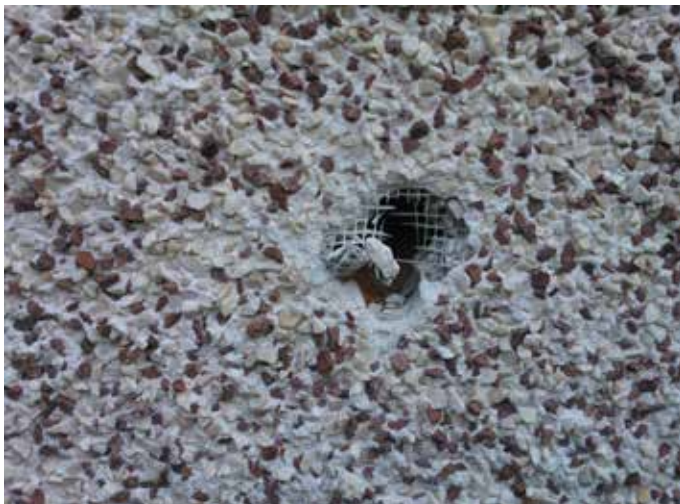
Figure 40: hole in a wall (from scaffolding used during construction)

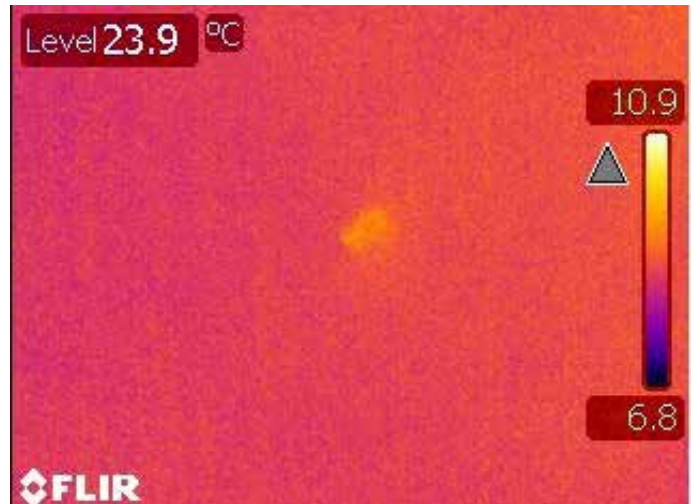
Figure 41: heat loss from the hole in a wall

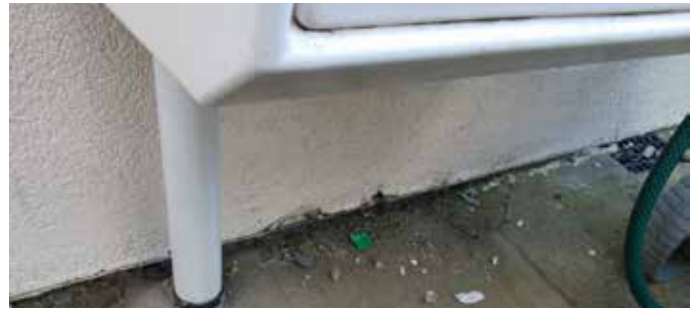
It is important when undertaking external wall insulation work of this nature that attention to detail is paramount. Poor or inconsistent finishing of details can and will lead to a reduced level of integrity, causing either early failure or poor performance. Figure 42 below shows an EWI starter track already deteriorating, although only undertaken seven months before the site survey. This increases the risk of moisture penetration to the main wall, and reduced life span.

Figure 42: Penetrating damp potential in external wall finish

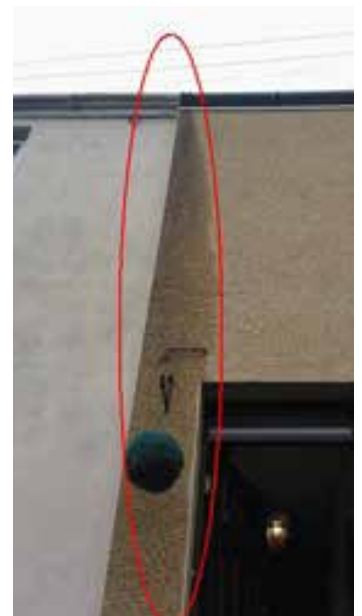
Figure 44: gutters connected of different material

These types of poor detailing are completely avoidable with better site supervision and quality control checks on site.

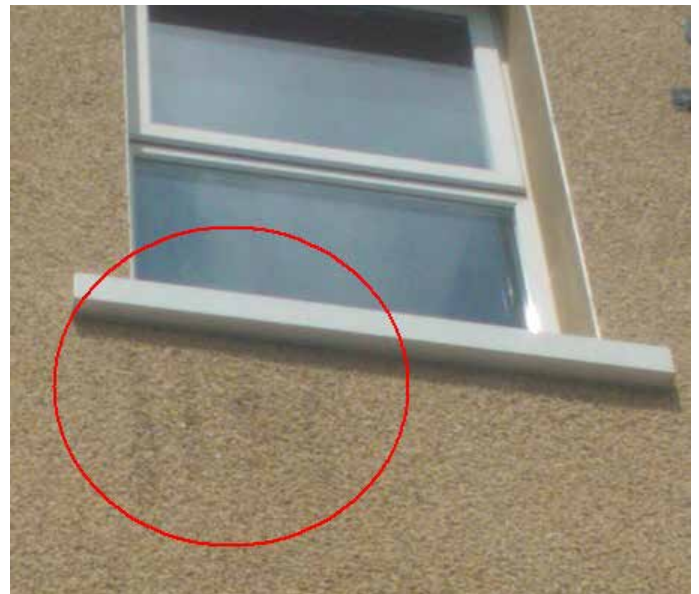
Figure 46: Incorrect finish of sill

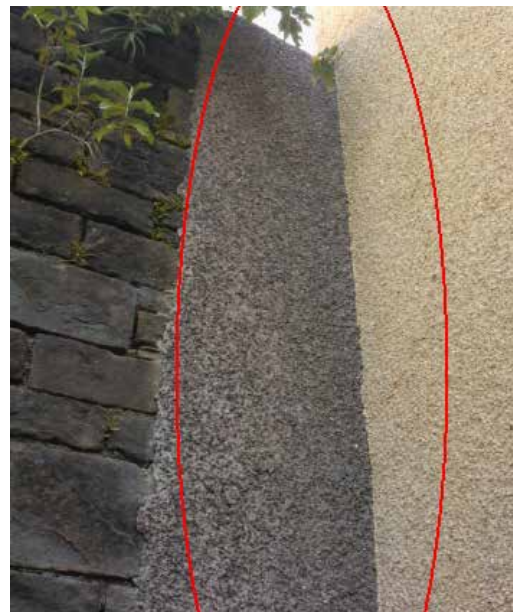
Common or standard practice results in the insulation being placed around the obstruction which increases the effect of the cold bridge, as discussed in FB61,<sup>12</sup> which demonstrates good practice and detailing when undertaking solid wall insulation.

Figure 47: Cold bridge exacerbated by placement of insulation around an obstruction

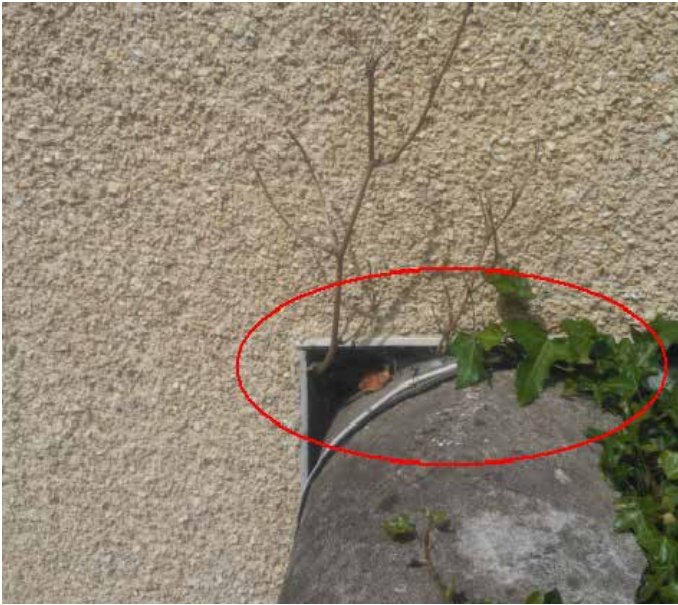
plant into the void left around the insulation. This plant is no doubt also sending roots behind the insulation which over time could lead to a destabilisation of the insulation boards and allow water ingress. Figure 49 shows plant growth on the existing wall that should be removed and cut back before the installation was undertaken, the site visit for this survey was undertaken less than one month after completion.

Figure 48: Plant growth allowed by poor detailing

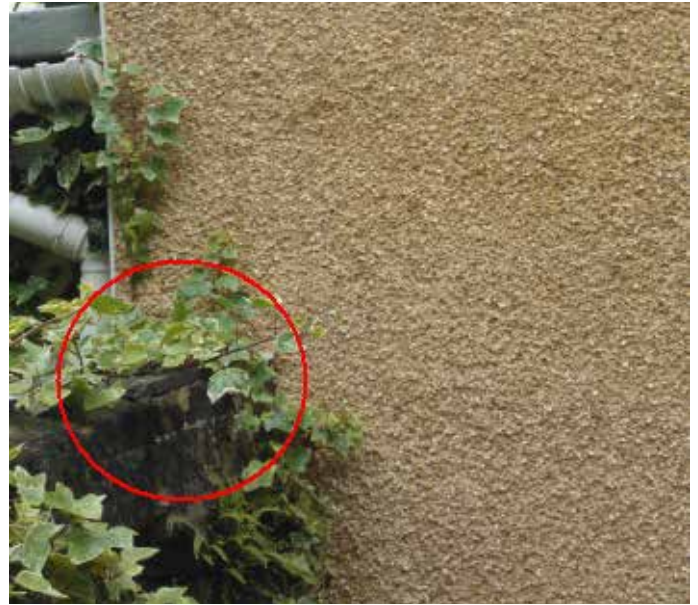
Figure 49: Close proximity of plant requiring pruning

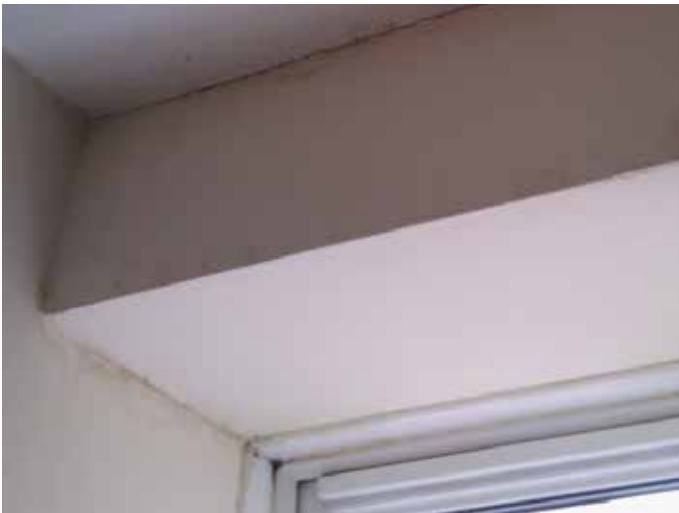
In the longer term, the issue with inadequate ventilation may prove to be more significant. Some housing providers reported issues with damp where none existed before, even though the EWI measures had only been fitted very recently.

Figure 50: Damp in the kitchen

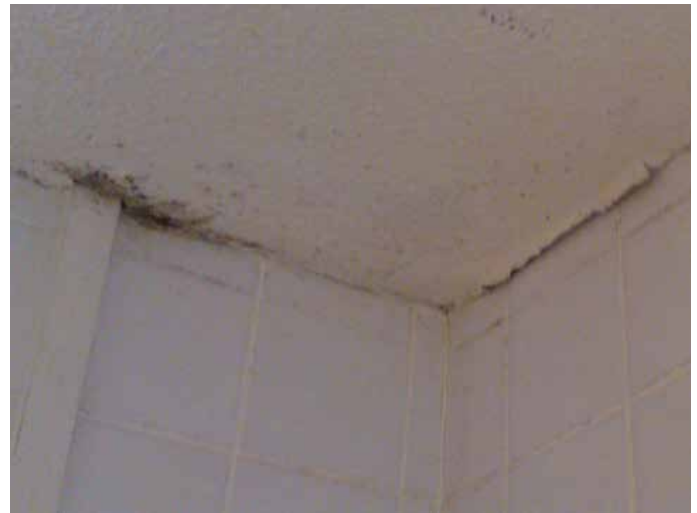
Figure 51: Damp in the bathroom

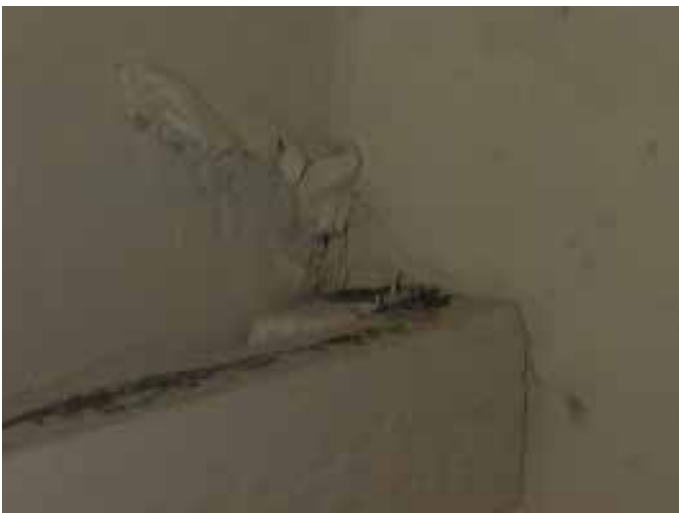
Figure 52: Damp in the wardrobe

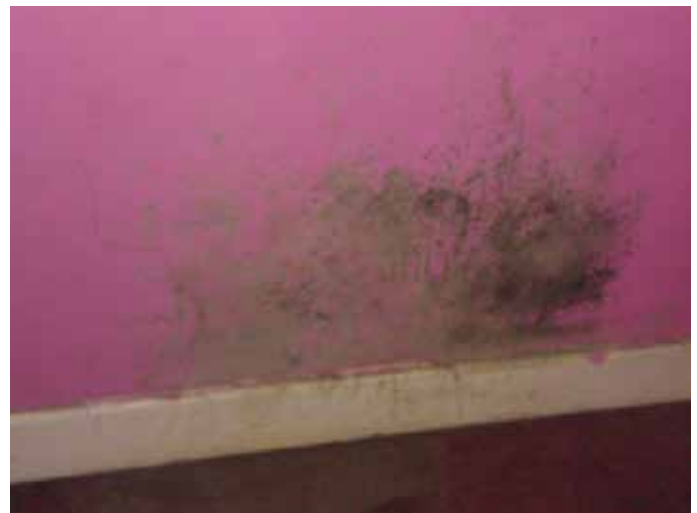
Figure 53: Damp behind a bed, removed for inspection
