Post Installation Performance of Cavity Wall & External Wall Insulation

Future Inns, Cardiff
14th December 2016

BRE: Post Installation Performance of Cavity and External Wall Insulation

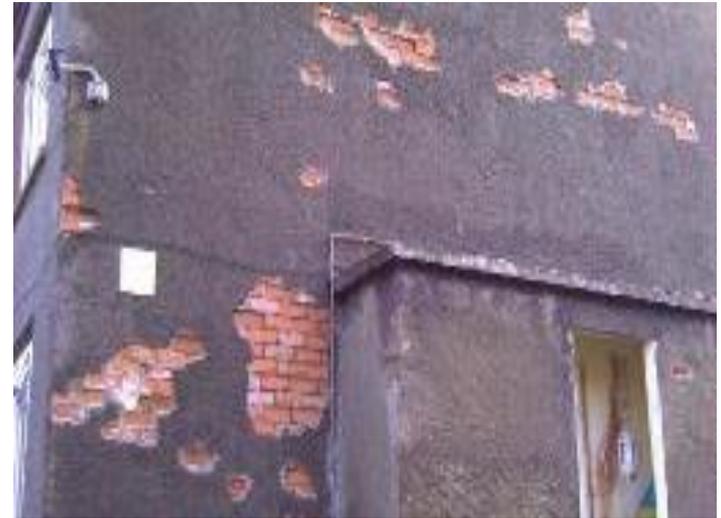
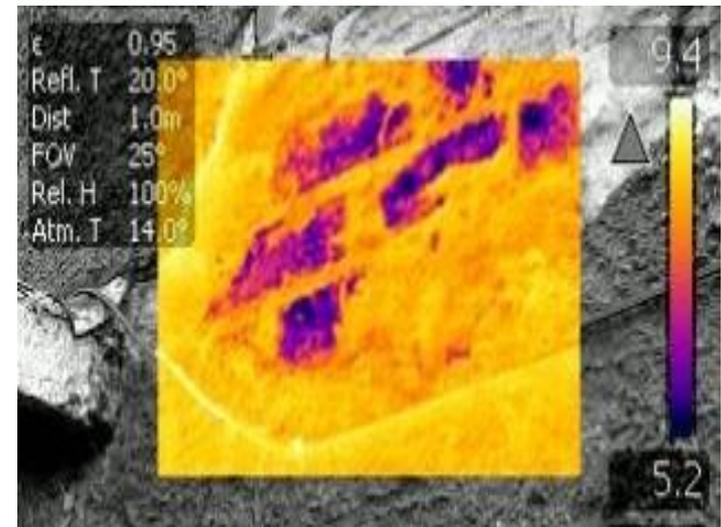
- Clusters of buildings with issues
- A range of reasons for non performance
- Narrow cavities <50mm outside of testing range

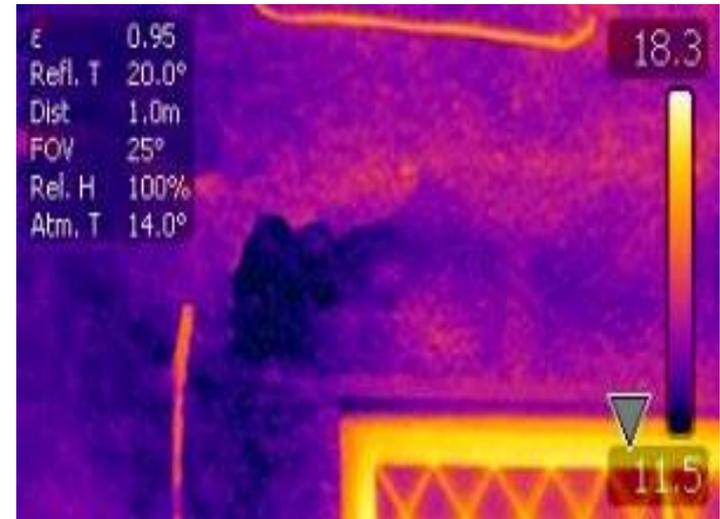
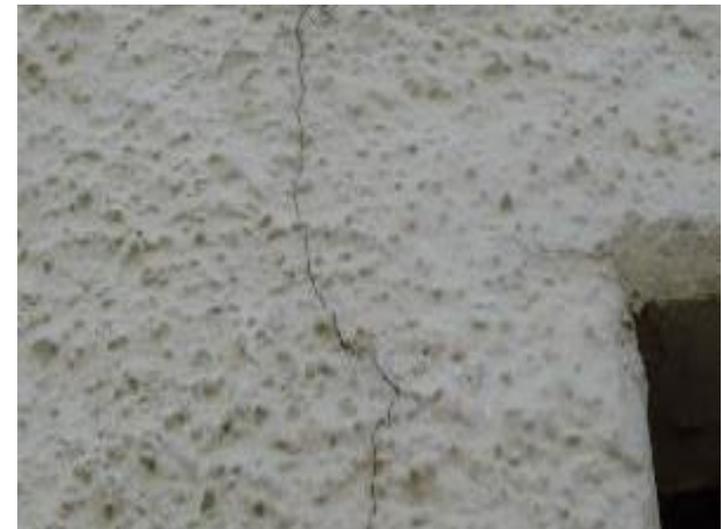
- No protection from local features
- Lack of maintenance and repair

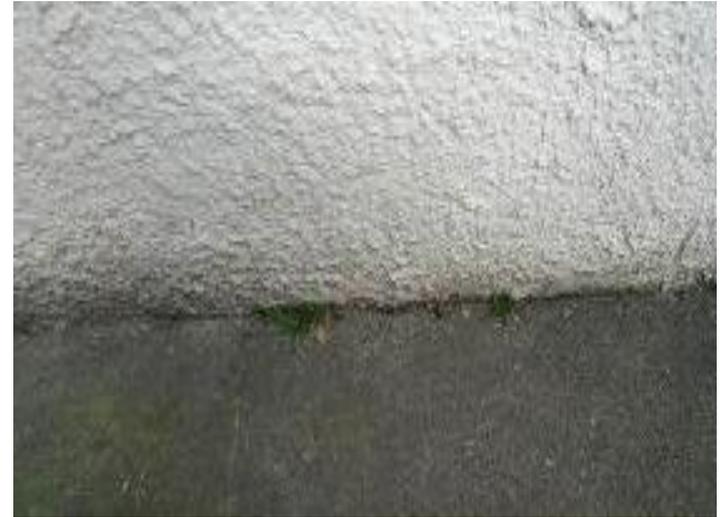
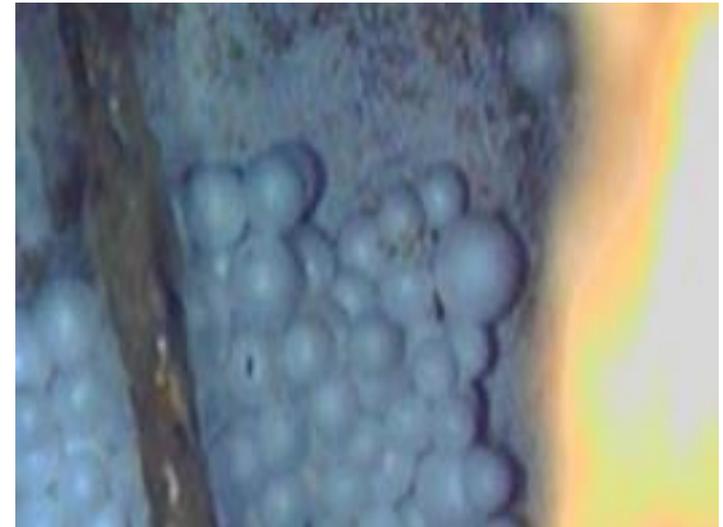
- Blocked cavities or partially filled
- Installations, outside certification
- No reference to BBA

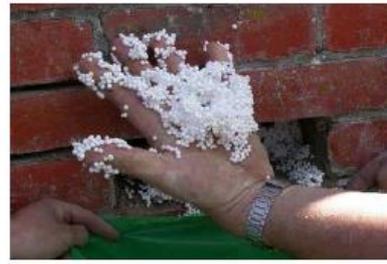
Figure 3: Example of saturated insulation

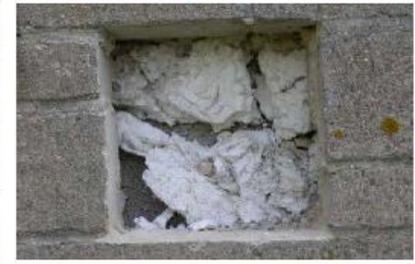
Figure 4: Example of saturated insulation

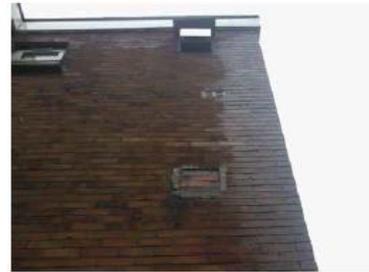
Other issues were identified where rainwater has overblown the roof and has saturated elements of the wall as shown in Figures 13 & 14 below.

Figure 13: Wall staining from water blown off the roof

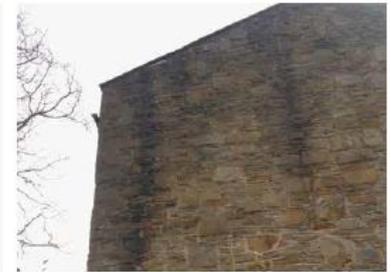
Figure 14: Staining from roof water run off

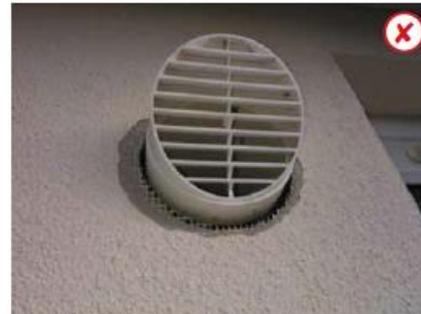
Figure 34: Unsealed extract fan in a bungalow

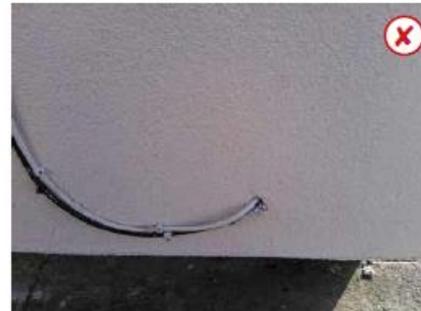
Figure 36: Unsealed wire penetration

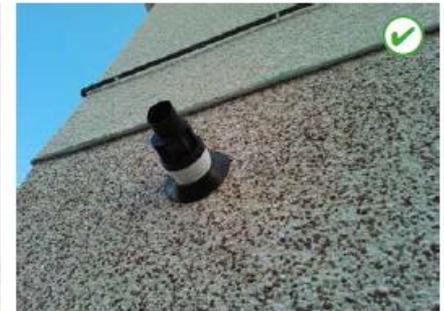
Figure 37: sealed penetration (good practice)

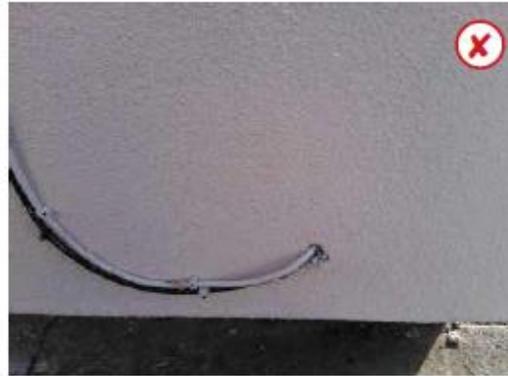
Figure 38 - cable clipped

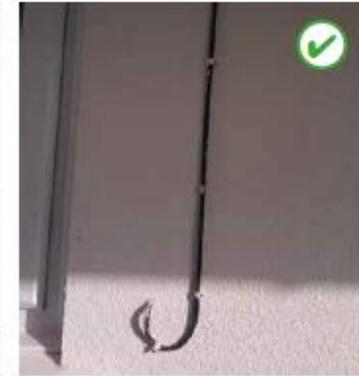
Figure 39 - cable clipped (good practice)

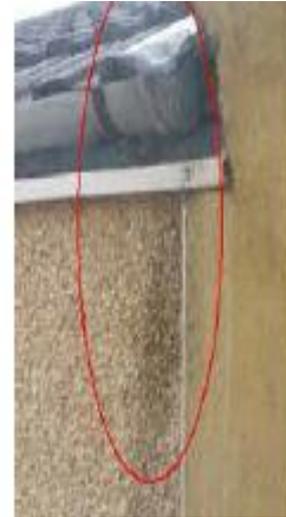
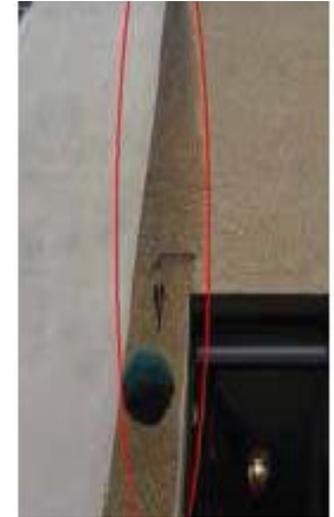
- Poor design or no design
- Poor workmanship
- Moisture ingress less than 4 months after installation

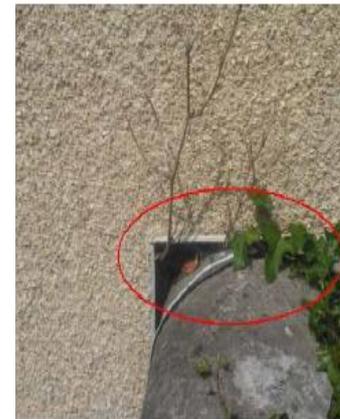
Figure 48: Plant growth allowed by poor detailing

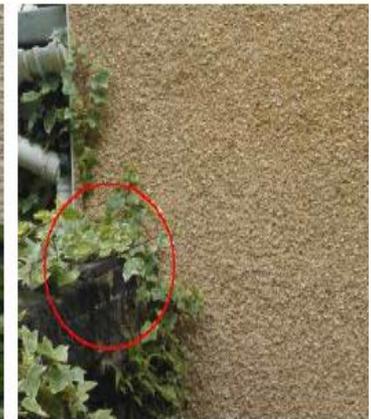
Figure 49: Close proximity of plant requiring pruning

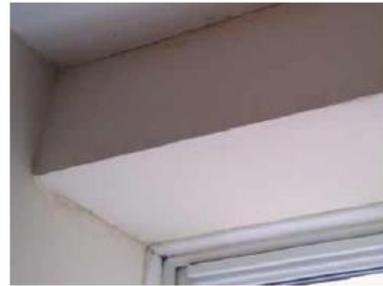
Figure 50: Damp in the kitchen

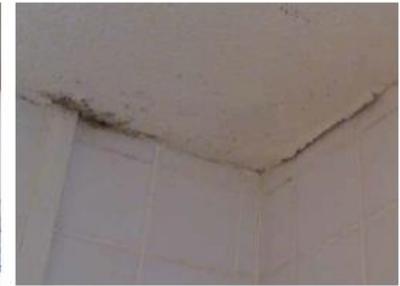
Figure 51: Damp in the bathroom

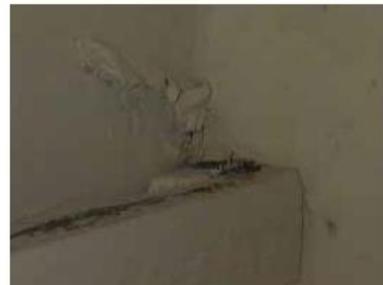
Figure 52: Damp in the wardrobe

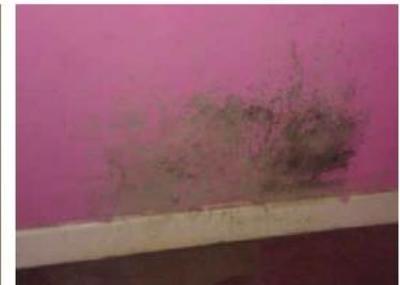
Figure 53: Damp behind a bed, removed for inspection
