CLOSING THE DESIGN VS AS-BUILT PERFORMANCE GAP

Richard Partington January 2014

Introduction to the Zero Carbon Hub

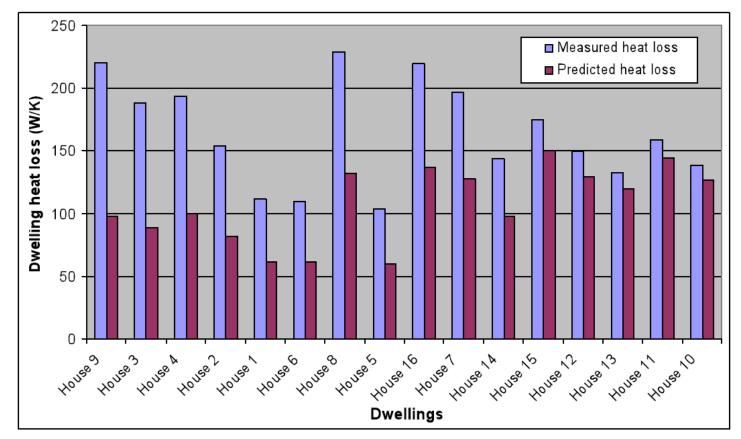
Measured v Predicted whole-house fabric performance

ZERO CARBON Figure I Measured v Predicted whole house heat loss for 16 dwellings⁴

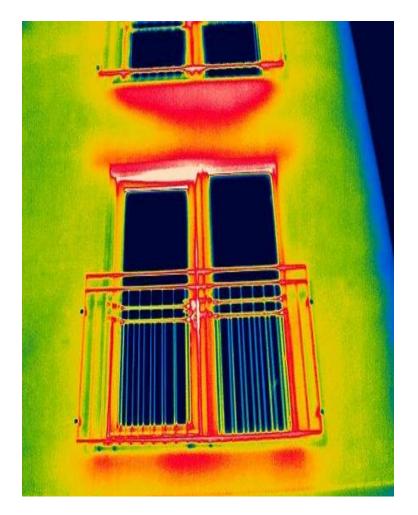
Thermographic imaging

- Internal & external images of the building fabric taken during the coheating testing
- Carried out early in the morning to minimise distortion to surface temperatures

- O Thermographic images reveal weaknesses in the build and design
- Analysis must be carried out by an experienced person

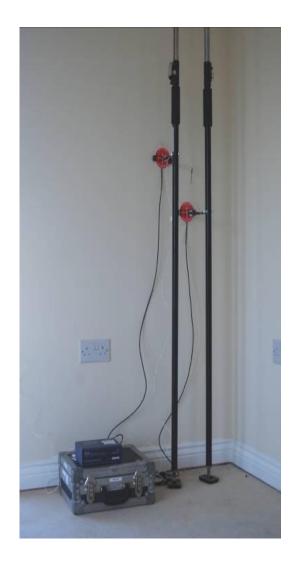
In-situ U-value measurement

- Heat flux testing carried out during co-heating test in one flat in each block
- Heat loss measured across north-facing external walls and also party walls

- The difference in measured and calculated U-values is similar to tests of this nature
- A party wall bypass was noted in both blocks

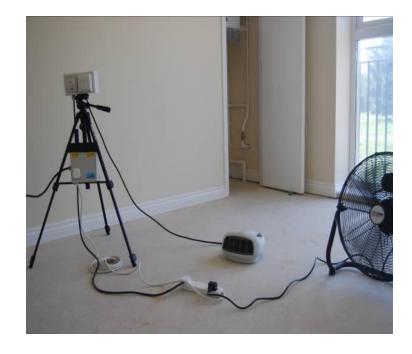
Co-heating test

- Test carried out in April, at very end of what is considered the suitable period
- Active site, so difficult to maintain controlled temperature in adjacent units

- Measured heat loss was greater than calculated heat loss
- Result at higher end of scale of published test results
