# Post Installation Performance of Cavity Wall & External Wall Insulation

This scoping study presents the results of an investigation of unintended consequences (unplanned side-effects such as damp and cracking in walls or other faults) for a small sample of Welsh dwellings which have been retrofitted with wall insulation. The primary aims of this study are:

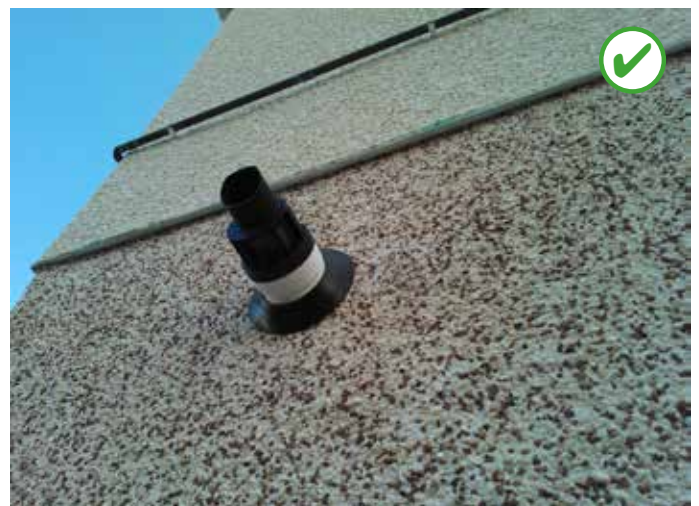
Figure 37: sealed penetration (good practice)

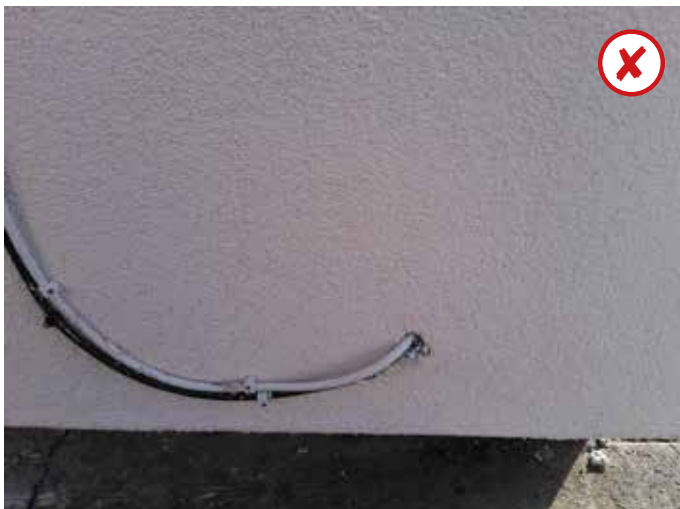
Figure 38 – cable clipped

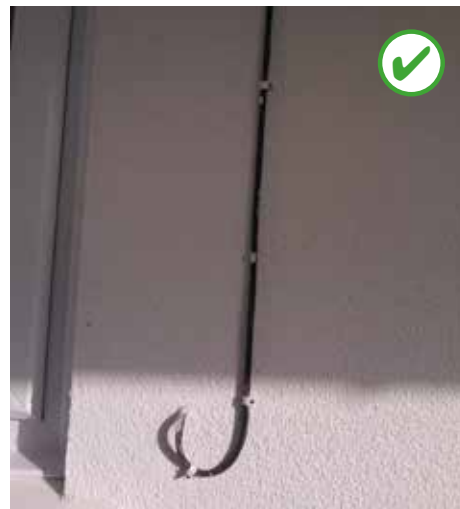
Figure 39 – cable clipped (good practice)

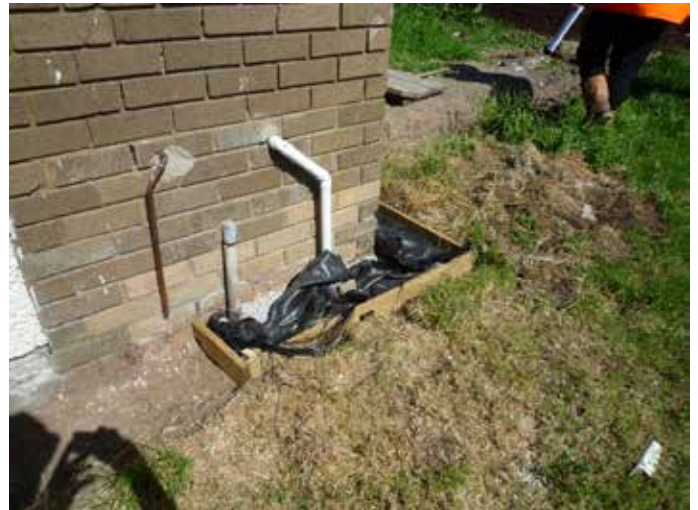
Figure 54: Ongoing works to provide soak away on raised ground areas.

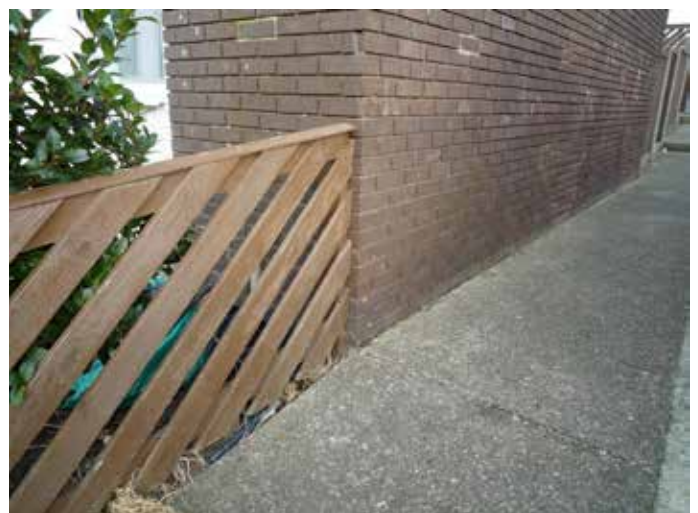
Fences and gates were tied into the dwellings at boundary edges see Figure 55. Fortunately, in this instance it was feasible to take down these features to allow the external insulation to be applied continuously to the walls at these points. This is preferable to installing the insulation around the existing feature, which would lead to a thermal bridge. There are some instances where it is not so practical to do this, such as at adjoining structures or porches (as is discussed below). In this case, fences and gates would be replaced after the EWI installation, ensuring that their mode of fixing would not damage the insulated render and would not introduce new detrimental thermal bridging points.

Figure 55: Typical fencing abutting main walls prior to EWI installation

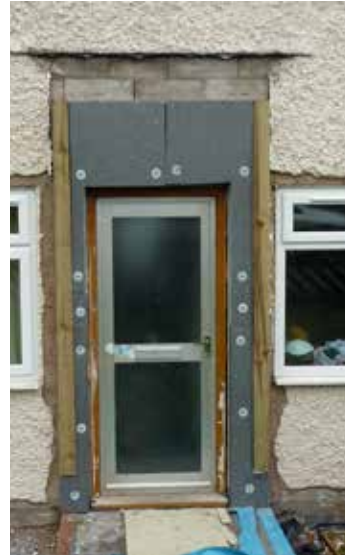
While it was possible to remove and replace some features around the dwellings to accommodate the externally applied wall insulation without introducing potential thermal bridging issues, the porches of the dwellings were more problematic because they were integrally tied into the structure of the buildings. It was therefore recommended that the porches be removed from the buildings and insulation applied behind where the porches had previously been tied into the structure. This would allow the continuation of the EWI across the front of the building where the porch had previously been attached. This could then be subsequently enhanced by the use of high performing insulation to minimise the cold bridge of the rebuilt porches, as shown in Figure 56 below.

Figure 56: Porch removed and cold bridge removed

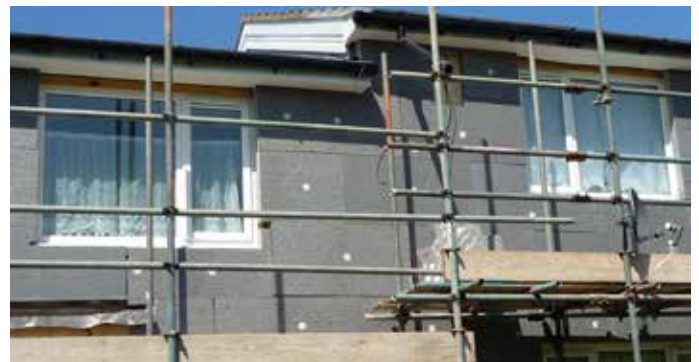
It is often the case in existing dwellings that the as-built original eaves and gable overhangs are insufficient to accommodate an additional layer of externally applied insulation. In such cases, it is common for installers to apply a finishing cap at the top of the insulation. However, there are reasons why this may not be considered ideal. The first is the overall visual appearance of the dwelling after such treatment, although this may go unnoticed by many people and is generally considered a low priority issue, and secondly this detail is reliant on flexible sealant to provide a watertight seal, which increases the risk of water penetration if not undertaken correctly or regularly maintained. Figure 57 shows good practice employed by Cartrefi Conwy, which is not only more aesthetically pleasing, but also reduces the cold bridging effects and potential risk of condensation and poor performance.

Figure 57: Extended eaves detail

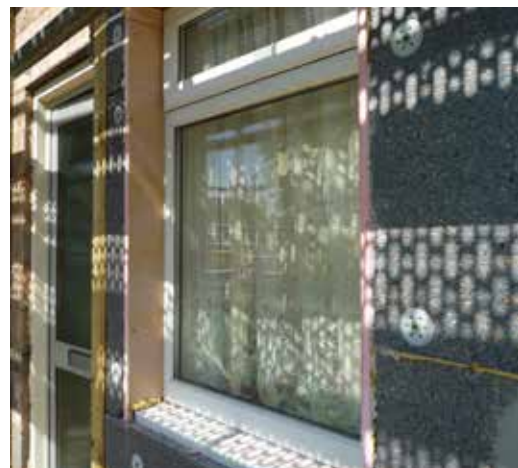
The choice of detailing of external wall insulation around windows can also introduce or exacerbate thermal bridging at the window reveals if the substrate wall surface remains exposed to the external environment behind the newly applied external insulation layer. This is quite common since often the thickness of the visible window frame is deemed to be insufficient to allow additional insulation to be returned into the reveal to cover the substrate wall and seal against the frame. Windows or doors may also limit the potential for this additional insulation to be applied if its thickness introduced an obstruction to the opening casement.

Figure 58: Insulated reveals and head

As the windows to the properties were modern and well performing, it was not a cost effective measure to remove and refix the windows to completely address the issues of cold bridging. The next best approach was taken the introduction of high performing insulation to the reveals and heads, as shown in Figure 58.
